MILLER
CONSULTING
ENGINEERS

Subject: Condition Assessment Report
2400 NW 153rd Avenue, Beaverton, Oregon
MCE Project Number: 140271

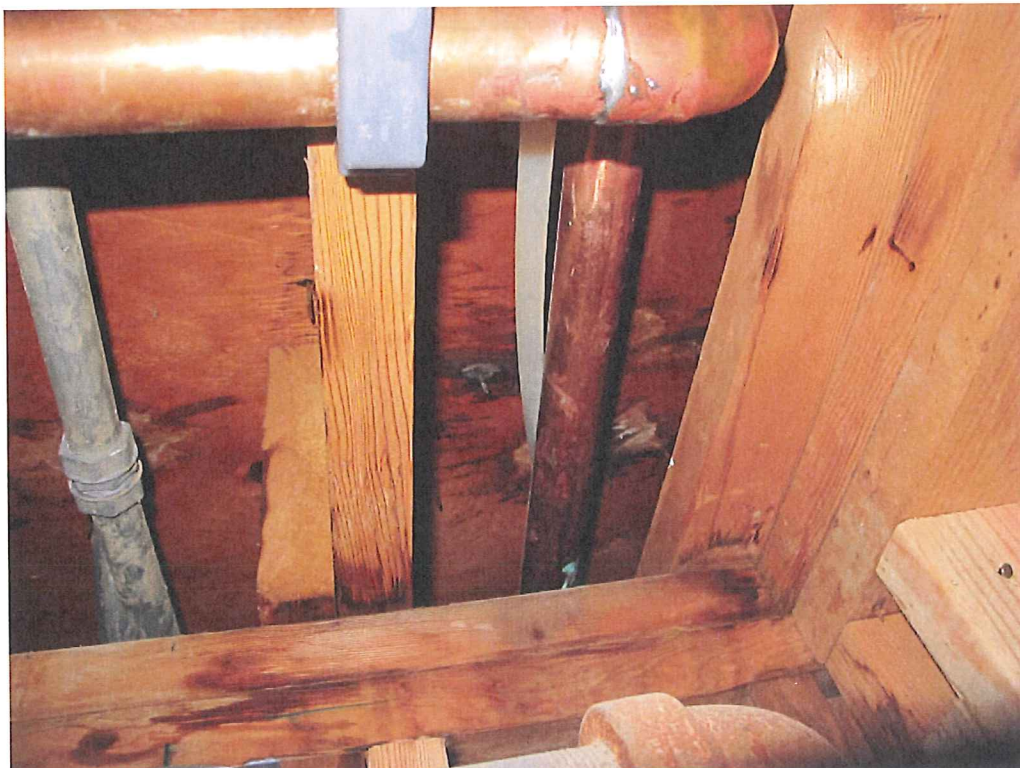
Photograph 2685

The staining on the wood shown in Photo 2685 shows typical damage observed above the shower stall in the building.

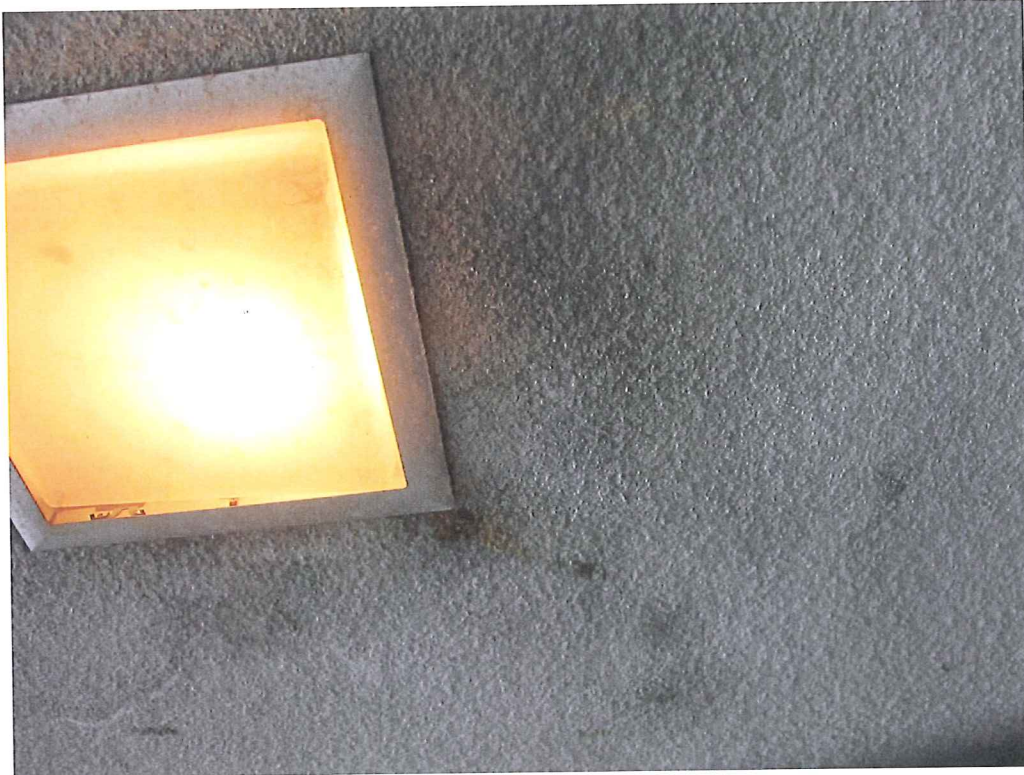
Photograph 2698

Under the elevated slab water is leaking through the slab and into the embedded electrical fixtures. (See Photos 2697 and 2698.)

Our office was only provided page 3 of the drawing set that has detail 6 of 3 showing a detail cut at the edge of the slab. This shows #4 bars tying the structural slab to the concrete walls and beams, but the bars extend less than 2' into the slab. There is another cut 4 on page 10 that we do not have. Based on the steel in the slab (indicated on page 3 of the drawings) the current slab is inadequate to support the code loads. Based on the reinforcing in the remainder of the building, it seems unlikely that the slab does not have additional reinforcing in it. We recommend that either the other drawing page is located or partial demolition of the underside of the slab be done to verify reinforcing. If the slab is not found to have any additional reinforcing, the area should be temporarily shored until a long-term repair can be made. The waterproofing of the existing slab appears to have failed allowing for water to drain through the slab and enter into the light fixtures in this area. We recommend that new waterproofing is installed.

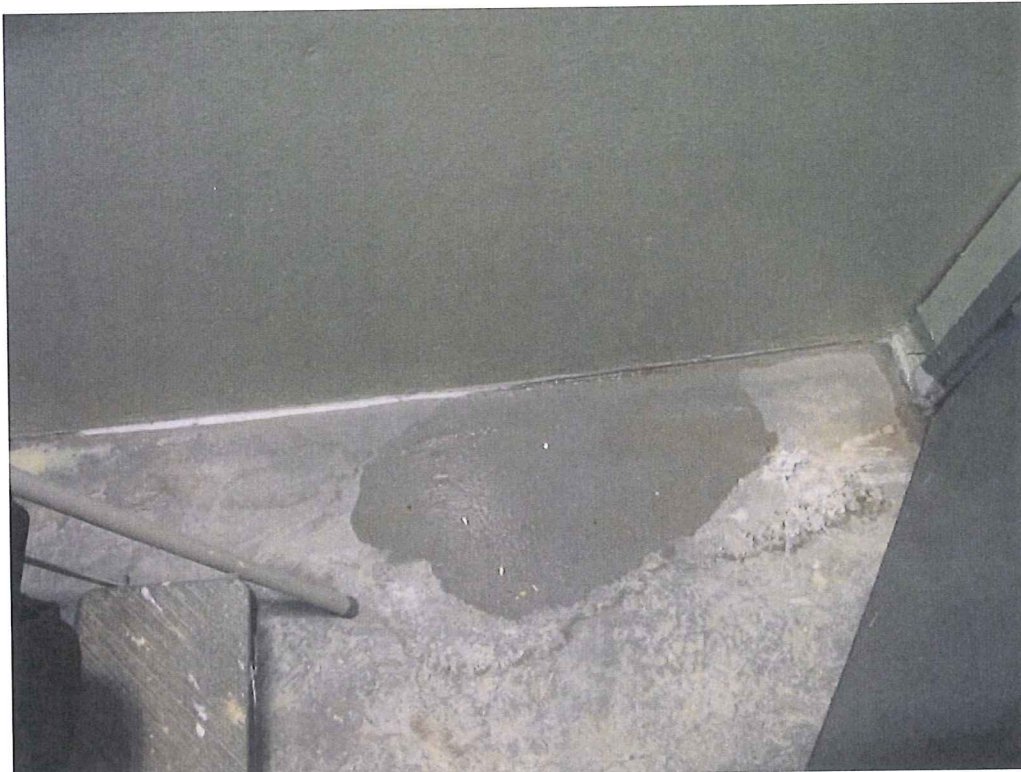
Photograph 2692

Photo 2692 shows a water puddle on the floor resulting from water leaking through the locker room concrete wall near the northwest entry door.

Slab jacking uses concrete slurry under pressure that is also known to plug drains so it is likely that the drains around the basement have failed resulting in leaks through the concrete walls. The drawings do not indicate waterproofing on the back side of the basement walls. We recommend that the walls are waterproofed when the slab and drains are removed and replaced.

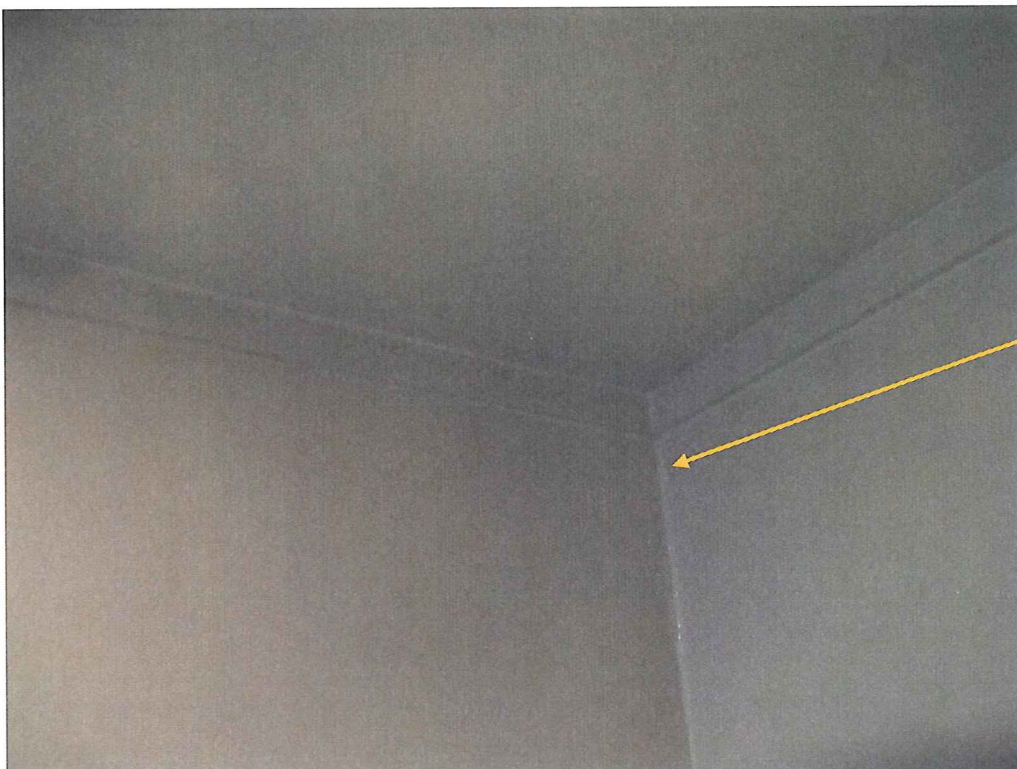
Photograph 2701

Photos 2701 - 2704 shows water leaking into the south locker room wall.

Water dripping
down wall

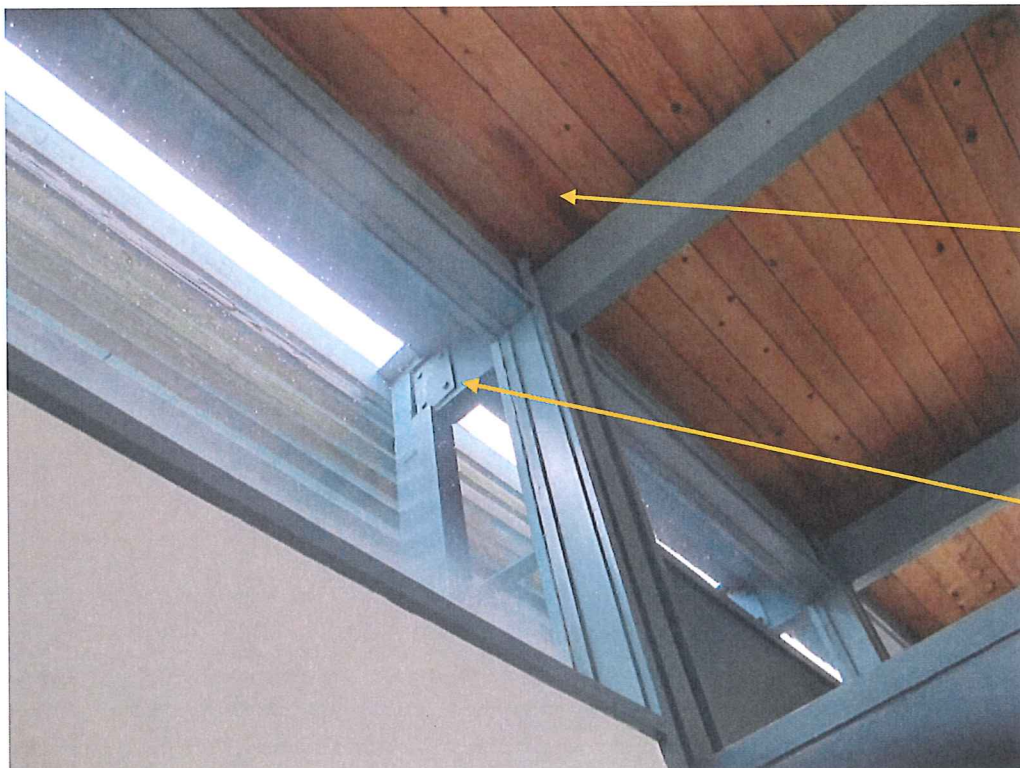
Photograph 2713

Photos 2713 and 2716 shows water staining of the decking near the support beams, as well as apparent dry rot of the wood screening members outside the windows. The wood members attaching the screening appear to have been notched to match the size of the beam and are likely locations for wood decay if not adequately protected from the moisture.

The decking of the roof has dark staining around the perimeter and near every beam location which is an indicator of decay from water intrusion. This could be from leaks in the roof or condensation from below. The roof will eventually need to be replaced. Further investigation should be done to determine the amount of decay. This will help determine the amount of decay in the roof and when replacement will need to occur.

Exterior wood members shall be pressure treated and or protected from the weather. Remove all decayed members of the screens. The connection supporting the screens needs to be investigated for decay.

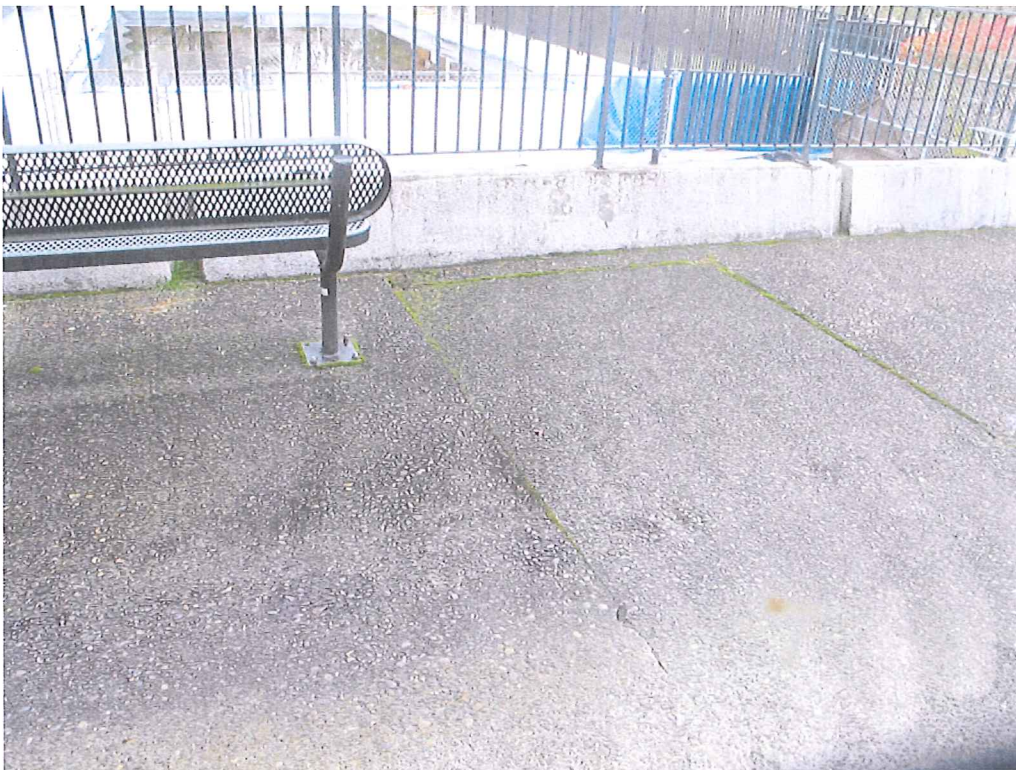
Photograph 2717

Photo 2717 shows settlement of the exterior slab prior to the drain. Photo 3545 shows this settlement is approximately 1 inch.

Based on Mark's report of the unsuccessful attempt of slab jacking the exterior slab in the past along with the continued settlement of the exterior slab, we recommend that the existing slab on grade be replaced along with any incompetent fill. This will also be an opportunity to replace the waterproofing of the elevated slabs.

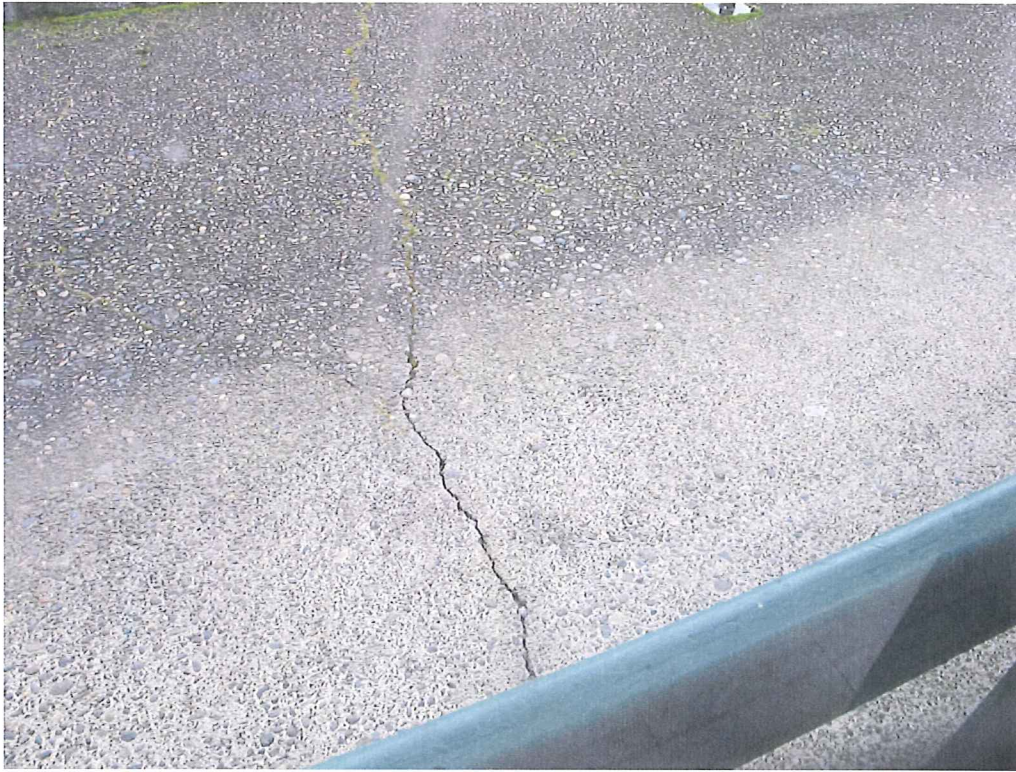
Photograph 2718

Photo 2718 shows a crack in the slab on grade adjacent to the elevated slab.

The crack in the slab between the slab on grade and the elevated slab is most likely due to a combination of shrinkage of the concrete and settlement of the slab on grade. The slabs on grade around the building have settled in the past and it is expected that this settlement will continue, especially with the slab elevation being lower than many of the drain elevations.

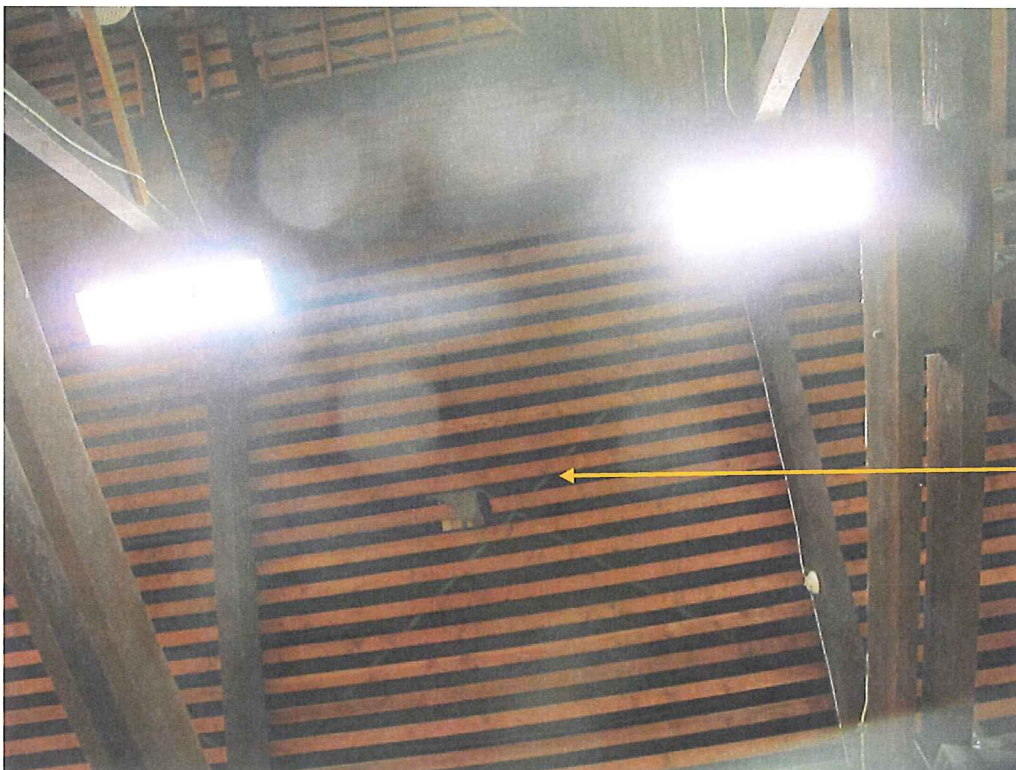
Photograph 2720

The roof diaphragm on the pavilion consists of skipped sheathing with steel X-braces in each lower bay as shown in photos 2720 and 2721.

**Steel X-bracing
(seen behind
wood members)**

Our scope for this building was a brief walk-through of the facility to look for visual structural deficiencies. Based on our visual observation, we were asked if we observed issues with the seismic capacity of this structure. We responded that the building is very tall and made of lightweight wood framing and typically this structural design would be controlled by wind loading rather than seismic loading. The visual weakness of the building was the roof diaphragm that consisted of skipped sheathing and steel strap X-braces. The walls of the building that will resist the most wind load only has one (1) X-brace, while the sides that see a smaller amount of load has three X-braces. Since the roof was reported to be rather new, a typical strengthening scheme is to add plywood to the interior of the skip sheathing on the single X-braced sides (east and west ends). We would recommend the building be structurally analyzed to determine the level of strengthening required.

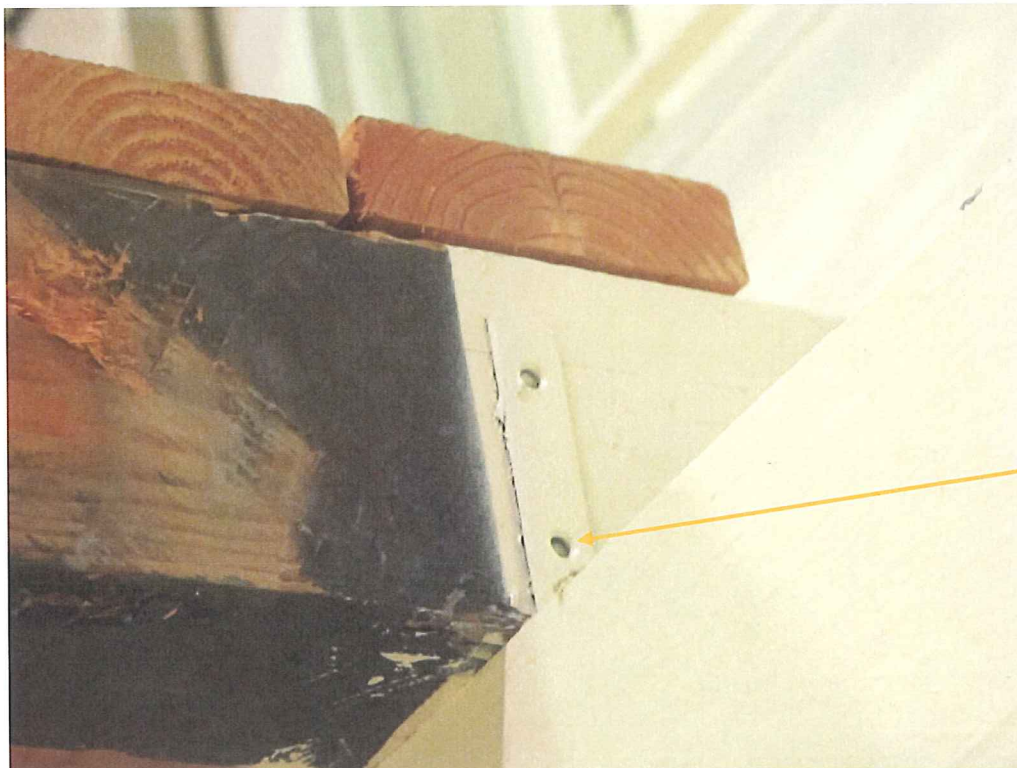
Photograph 2722

The basketball hoop on the west side of the building appears to have been recently replaced and has not been fully re-attached to the supports (see photos 2722). The back support of the beam was not visible.

Missing
connections

The connections in the bracing of the west basketball hoop are missing and the rear connection was covered. It is recommended that the fasteners be installed and a connection at the rear be verified.

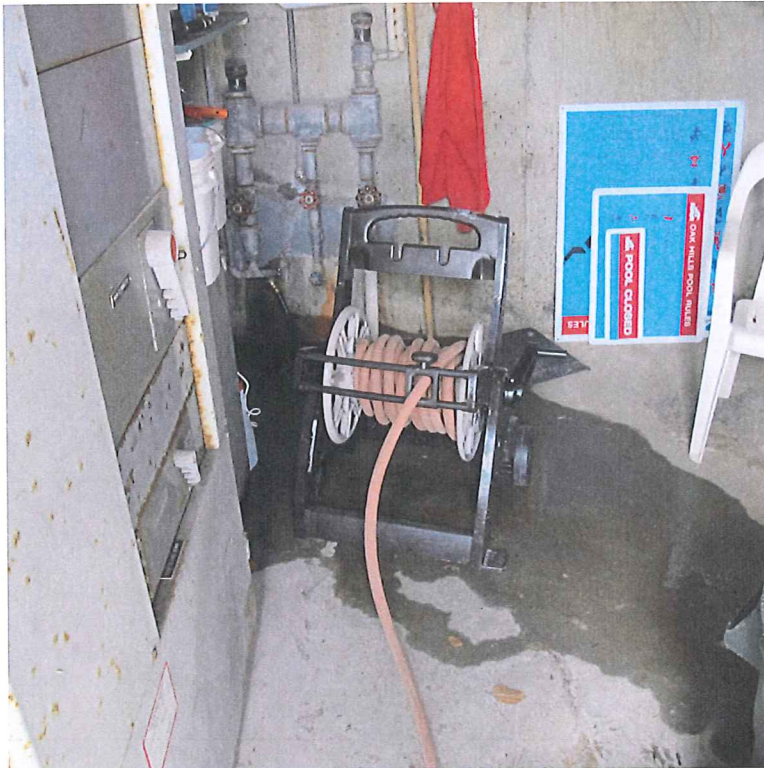
Photograph 3405

The mechanical room has electrical, water and gas elements all in the same building. Leaking connections for the water has made the environment wet and metal electrical boxes are rusted. Photo 3405 shows the condition on the day of our second site visit. Photo 3408 shows leaking faucet. Photos 3410 and 3428 show the rusted electrical panels.

First, it is recommended that a state-certified electrician review the water situation to ensure that there is not an electrocution issue and that the rusted electrical panels are serviceable and repair is made to the plumbing so it does not leak. Next, the building needs to have all of the deteriorated wood removed and replaced. Areas that are likely to get wet in the future should be replaced with treated wood. The flashing on the building needs to be redone so as not to the direct water back into the building or have water leak through nail holes securing the flashing. The building needs to have a full building envelope so water does not have direct contact with unprotected framing

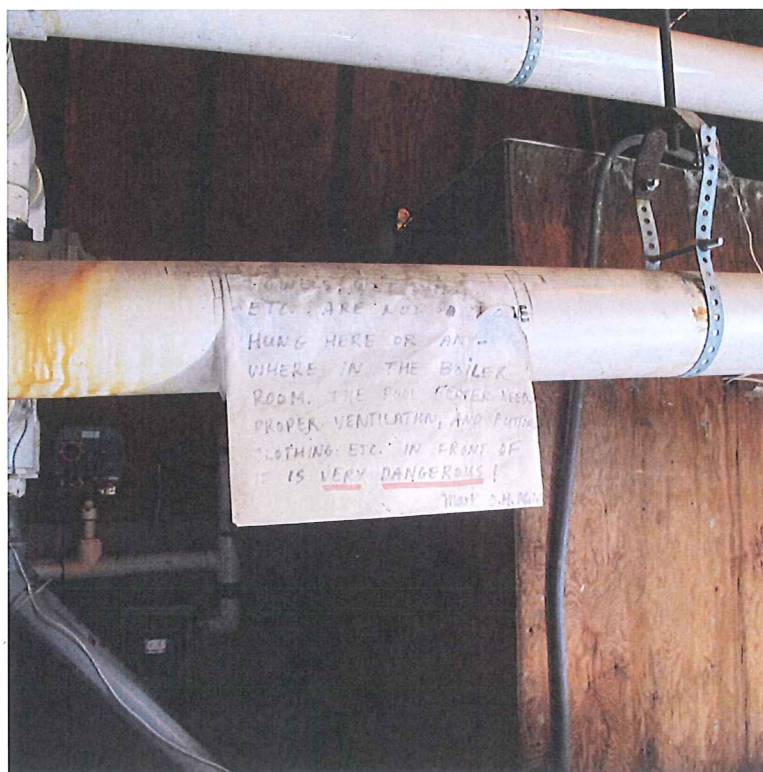
Photograph 3413

Mark posted a sign warning of some of the hazards in the room (Photo 3413). It is outside my area of expertise but I would also be concerned about electrocution with water so near the electrical and rusting panels.

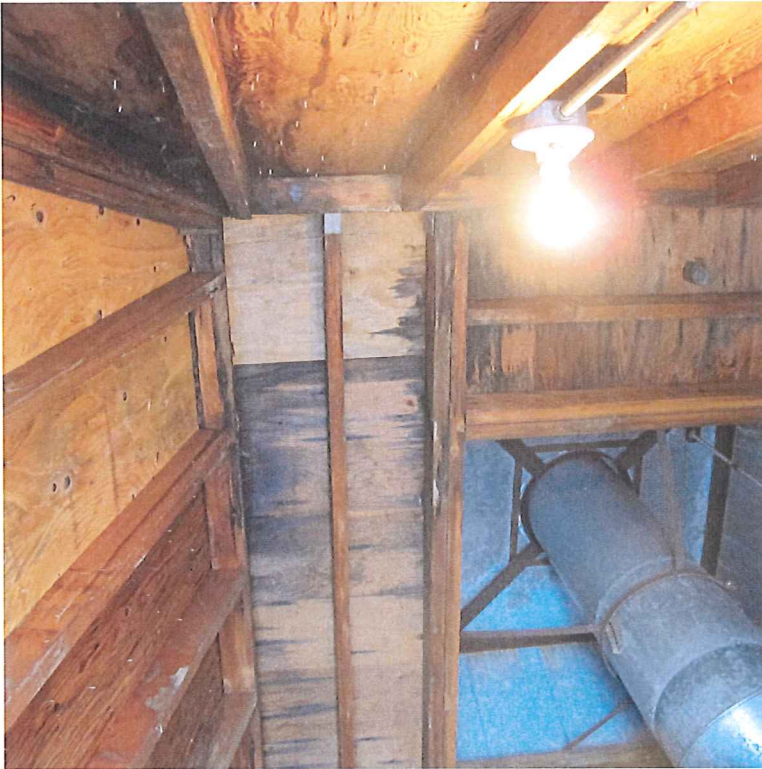
Photograph 3415

The roof and walls appear to have wood deterioration. Photo 3415 shows the staining of the roof and upper walls of the building. Photo 3424 shows deterioration of the studs near the door. Photos 3425 and 3430 show decay of the door and the surrounding door framing. The doors can no longer be secured due to the decay in the door and frames. The wood above the concrete walls are decayed in several locations. (See photos 3422 - 3435.) The lifeguard room door and floor are also decayed; see photos 3437 and 3440.

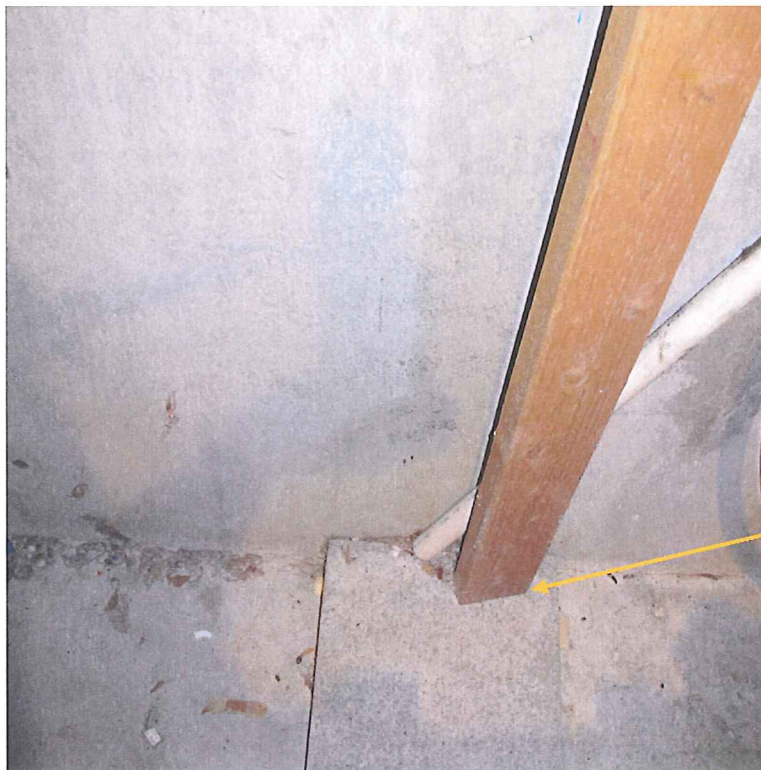
Photograph 3451

The original drawings indicate 6 x 12 beams which we assume were supported in steel brackets, visibly anchored into the concrete wall. The new beams are built-up 2 x 6 joists supported in some cases with just a single stud and without a positive attachment to the concrete footing below (see photo 3451).

Single stud
column; no
support at base

The floor framing does not match the original drawings and by visual observation does not appear to provide adequate lateral bracing or vertical support. The current floor system needs to be fully analyzed and a repair scope needs to be put together and completed for the building to be used. Damage to the columns supporting the roof also needs to be reviewed to see if it can take the code loading. The piping in the building needs to be secured to prevent damage to the system.

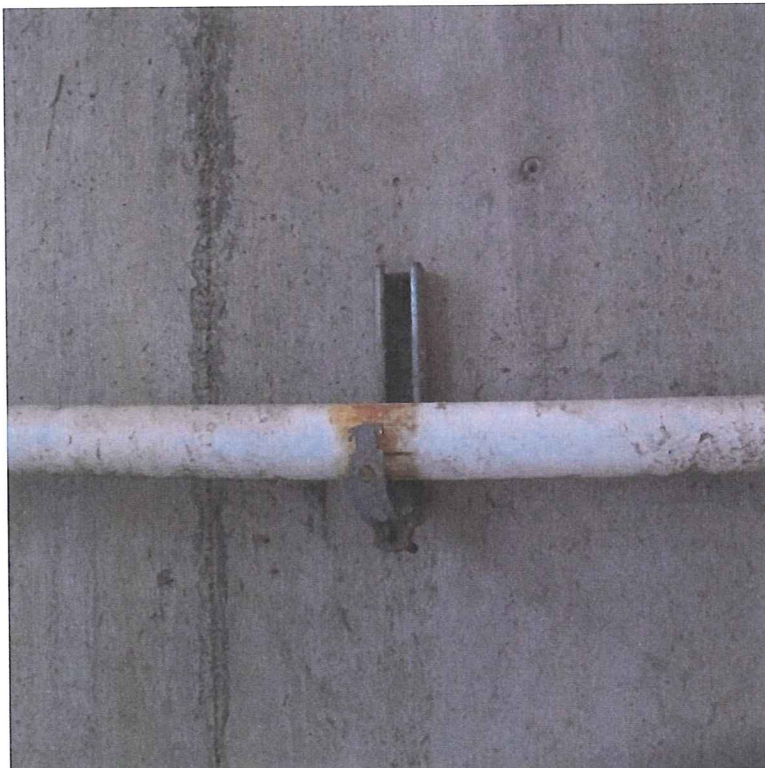
Photograph 3456

Photo 3456 shows a PVC pipe bracket that has come loose that is also supported by an electrical panel shown in photo 3461.

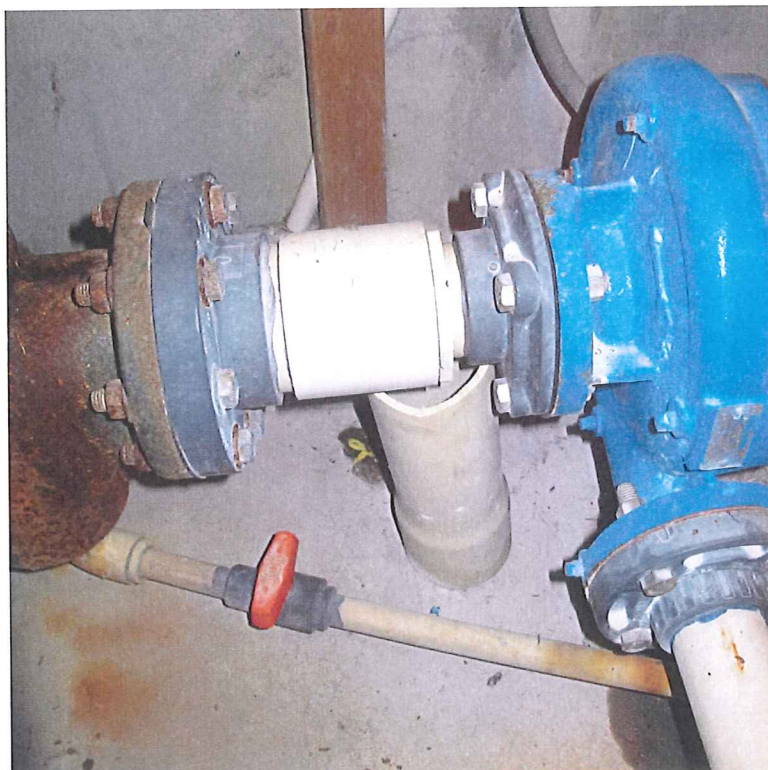
Photograph 3457

The mechanical piping is poorly supported and some of the supports have rusted away and do not bear on the concrete; see photos 3458 and 3459. Other supports do not have a positive connection to the concrete or the pump; see photo 3457.

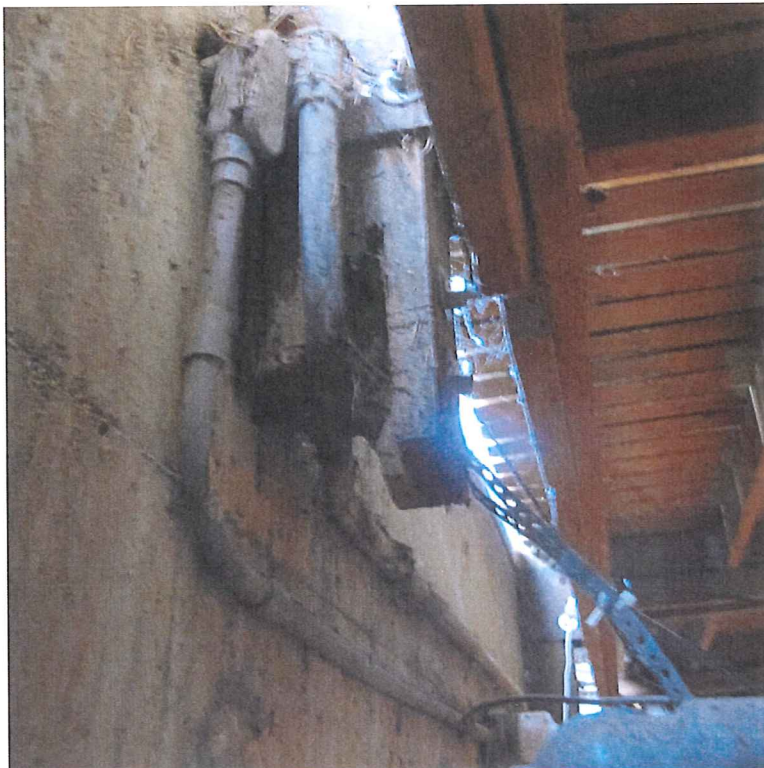
Photograph 3462

Photo 3462 shows serious alterations to the framing that reduce the capacity of the connections.

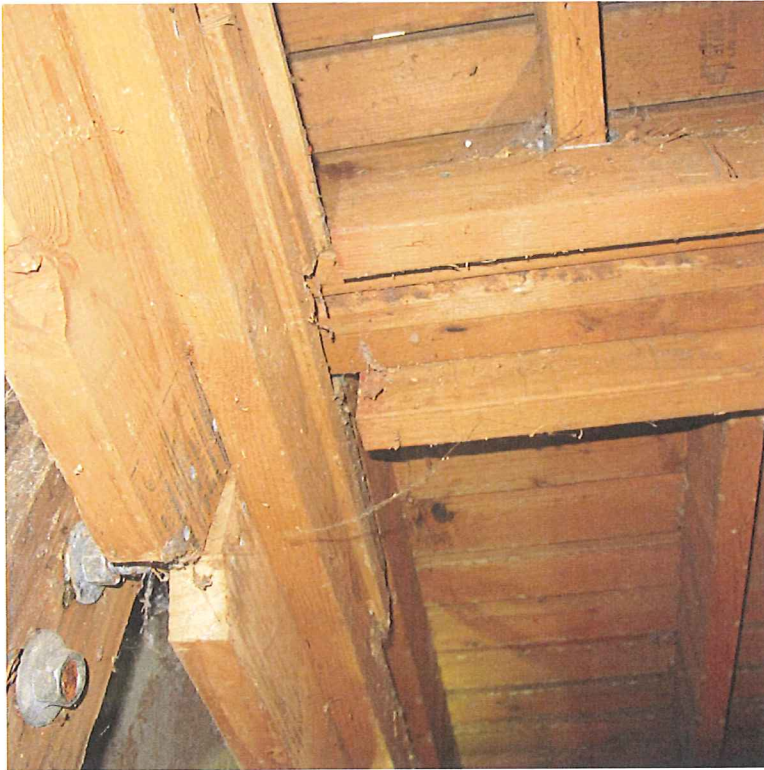
Photograph 3468

The built-up floor members do not extend to the support as shown in photo 3468.

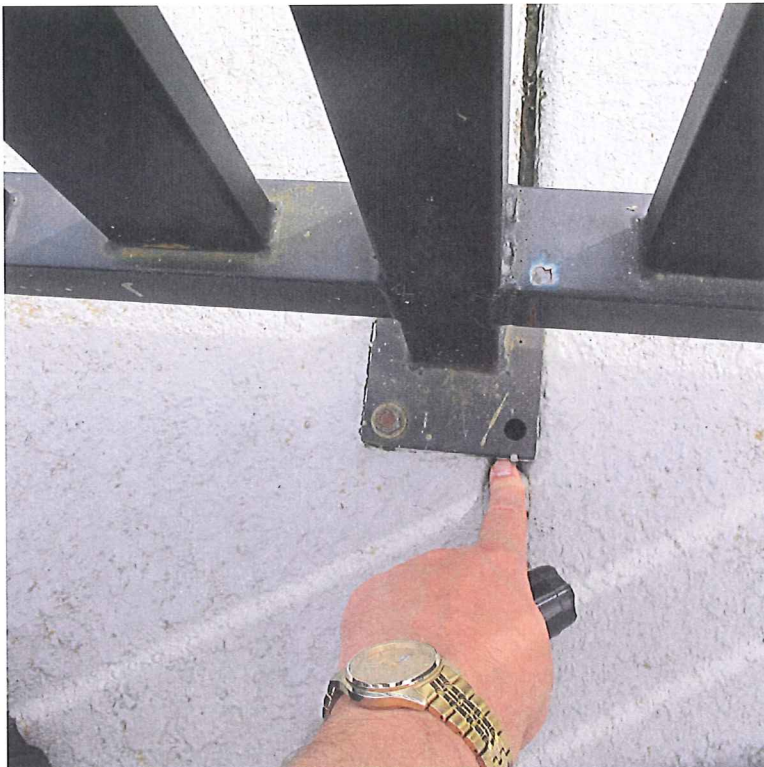
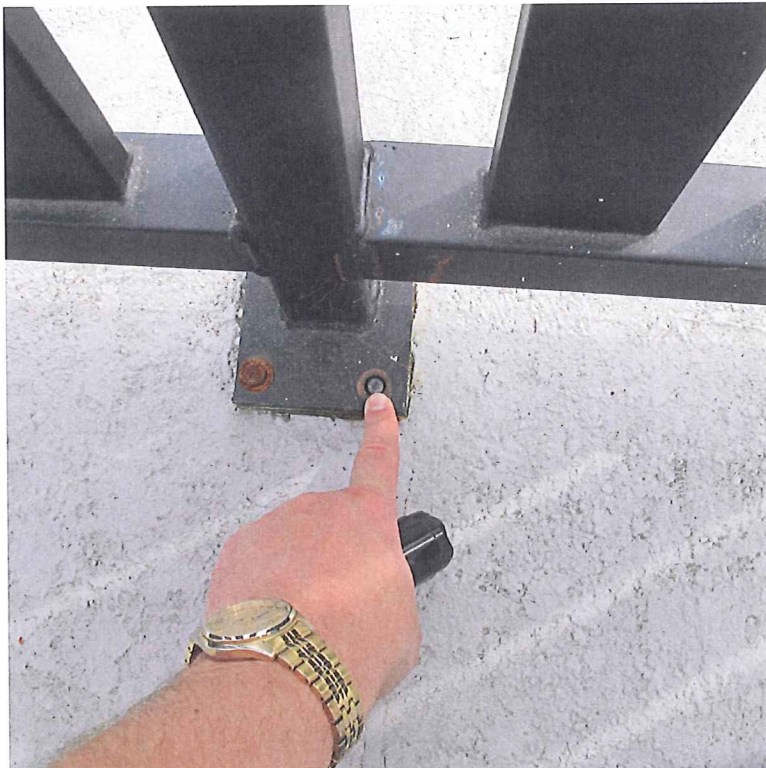
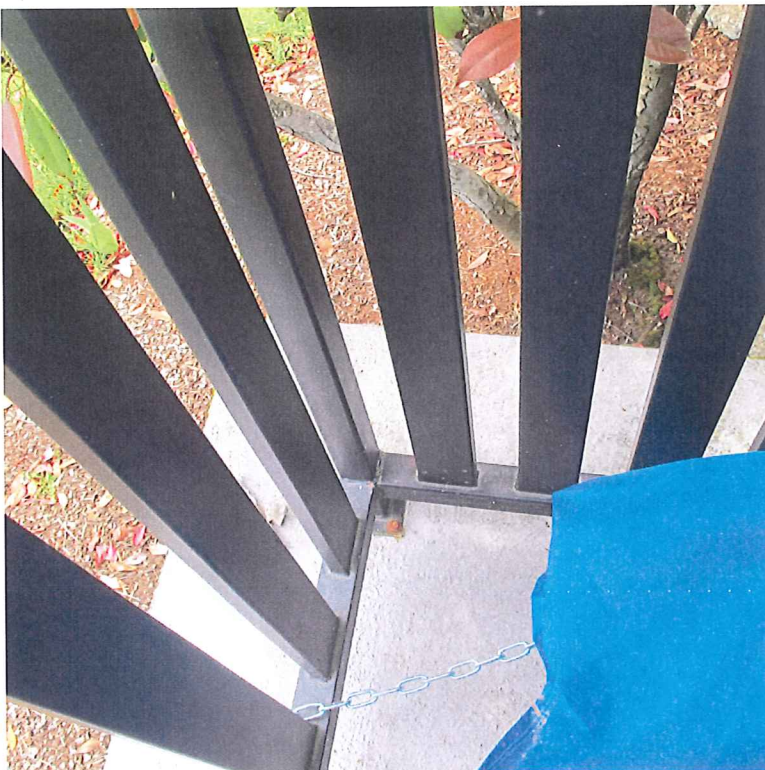
Several of the fence posts had missing or broken connections; see photos 3469, 3471 and 3473.

The exterior steel fence bases that have broken connections at the base and broken bases should be replaced. New bases should be welded to the post to match the code-required loads. There are several reasons for connectors and bases to fail, but the two most likely are thermal expansion, contraction and corrosion. Therefore we recommend that the new bases for the fence have slotted holes to allow for expansion and contraction of the fence and along the length. Corner posts that have damage may need oversized holes to allow for movement in two directions. The connectors need to be corrosion resistant and cannot be placed in or near the expansion joints of the concrete. Typical corrosion resistant connectors are stainless steel. The new connectors should have washers to span over slots and oversized holes.

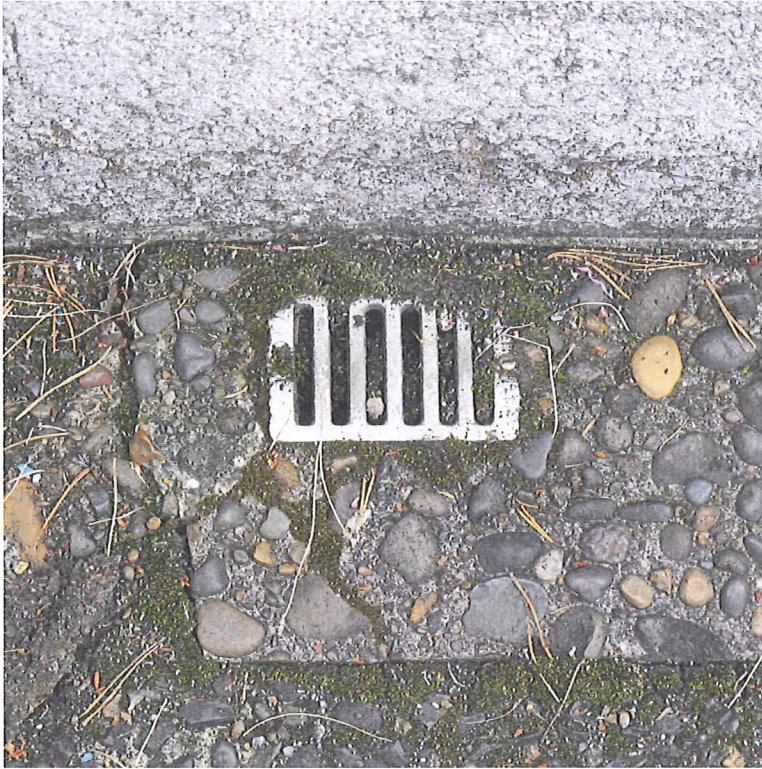
Photograph 3476

The drains for the sidewalks are plugged; see photo 3476.

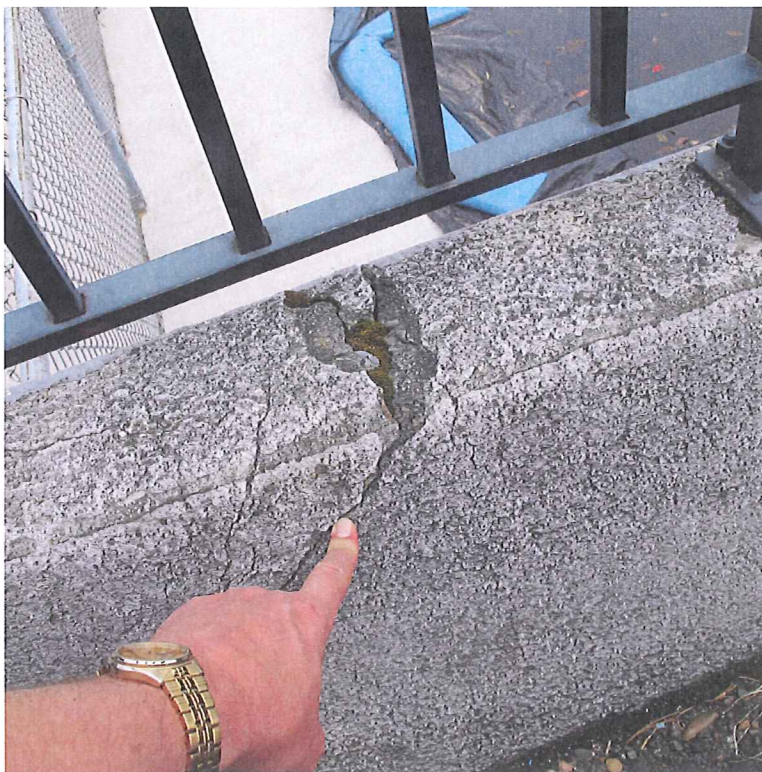
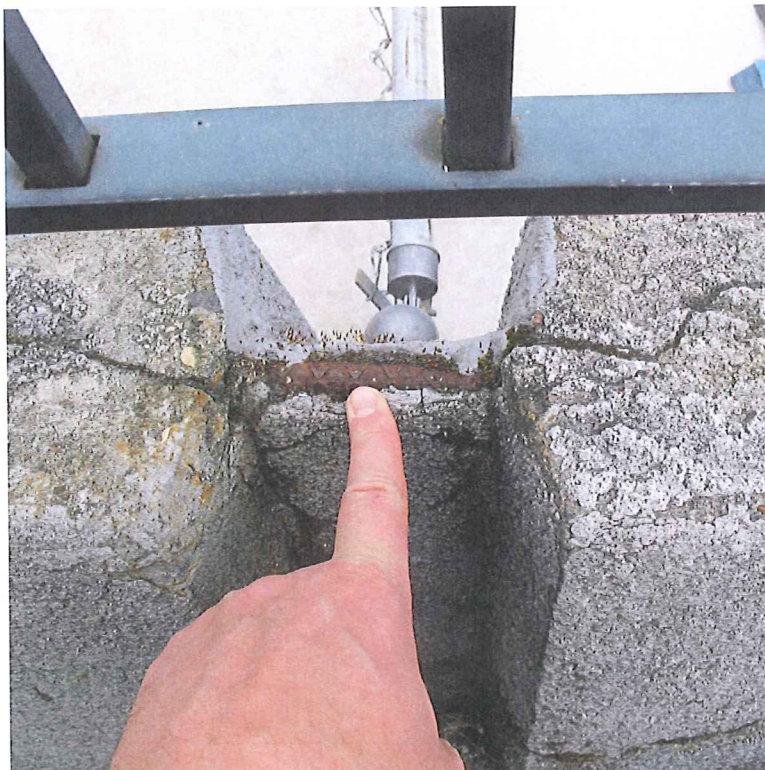
Concrete walls are cracked and have exposed reinforcing in several locations; see photos 3477 and 3478.

The existing concrete walls have steel reinforcing. The concrete is spalling due to rusting of the reinforcing steel. We recommend that spalling concrete be removed to the point where the rebar only has minimal (light) corrosion. The rebar should be cleaned to bright metal and coated with a rich zinc primer and patched back with a repair mortar as prescribed by the manufacturer. Due to the shallow cover of the steel we recommend that the walls be sealed with a coating so as not to allow water into the concrete. The top of the walls should be sloped so as not to let water pond.

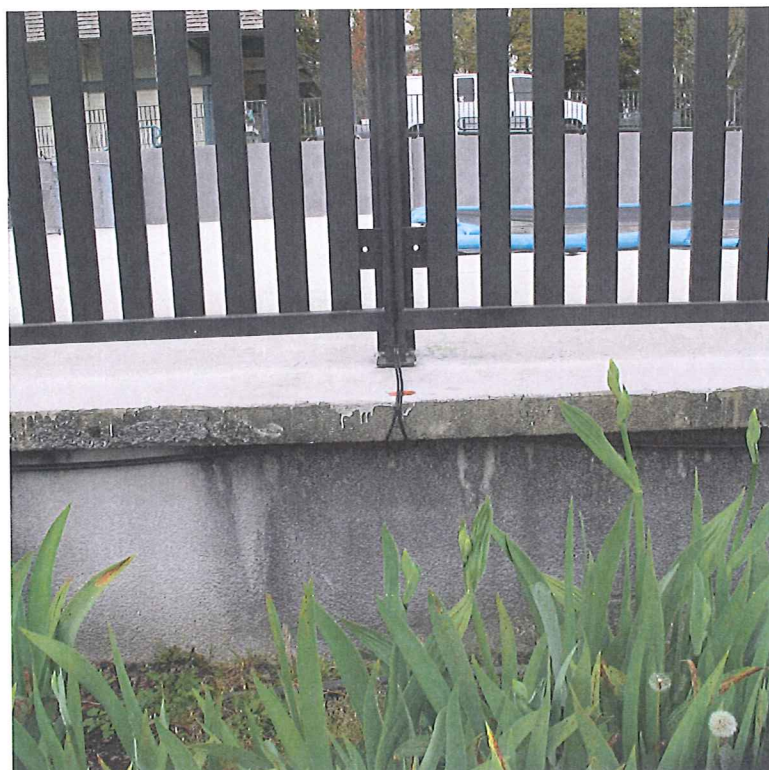
Photograph 3483

The fence bases are not supported on the concrete; see photo 3483.

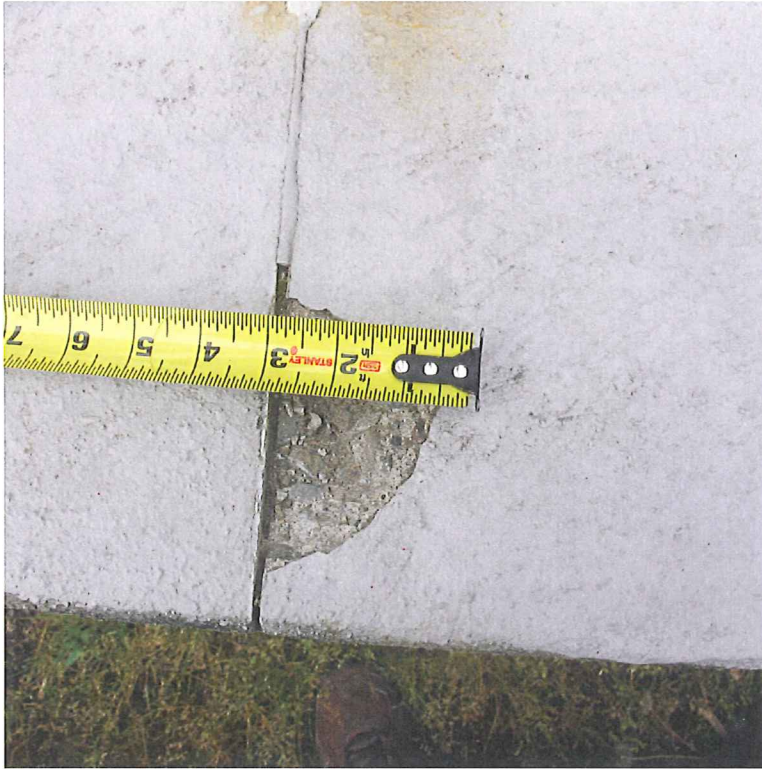
Photograph 3486

Photo 3486 shows chipped pool deck covering. Photo 3489 shows incomplete joint caulking.

The pool deck coating is cracked and buckled. This appears to be a result of applying coatings over cracks in the concrete deck that continue to move. At these locations, the coating should be removed and the cracks be ground out and the joint should be filled with sealant like the other joints in the concrete deck. The deck coating should be re-applied up to the edge of the joint.

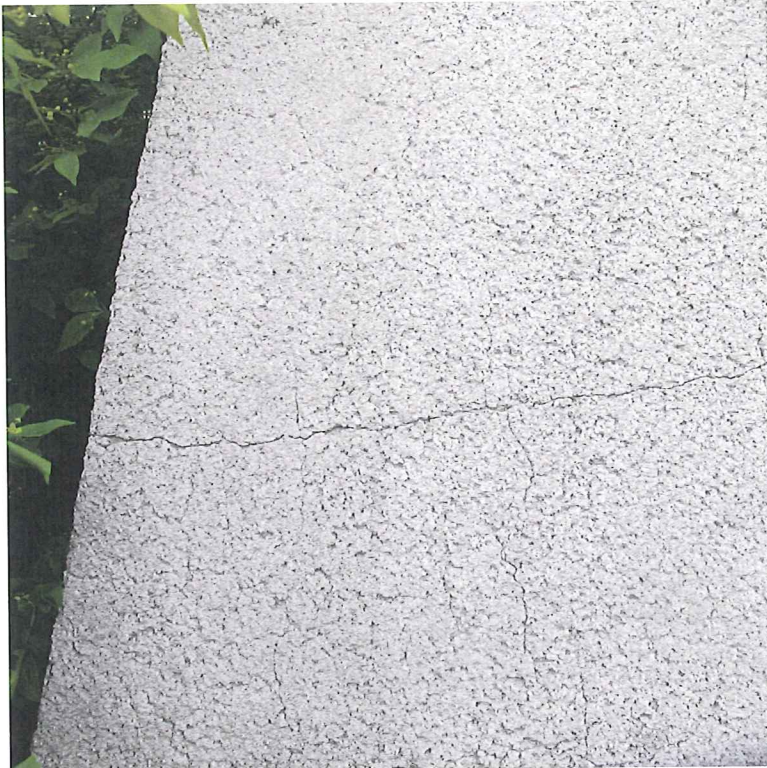
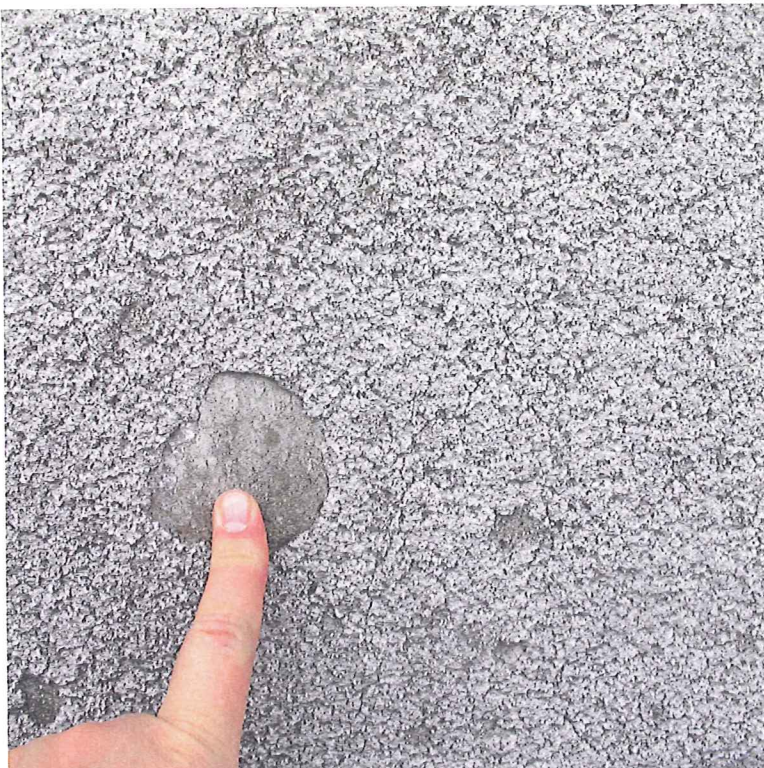
Photos 3490 and 3491 show cracking and chipping in the stucco coating.

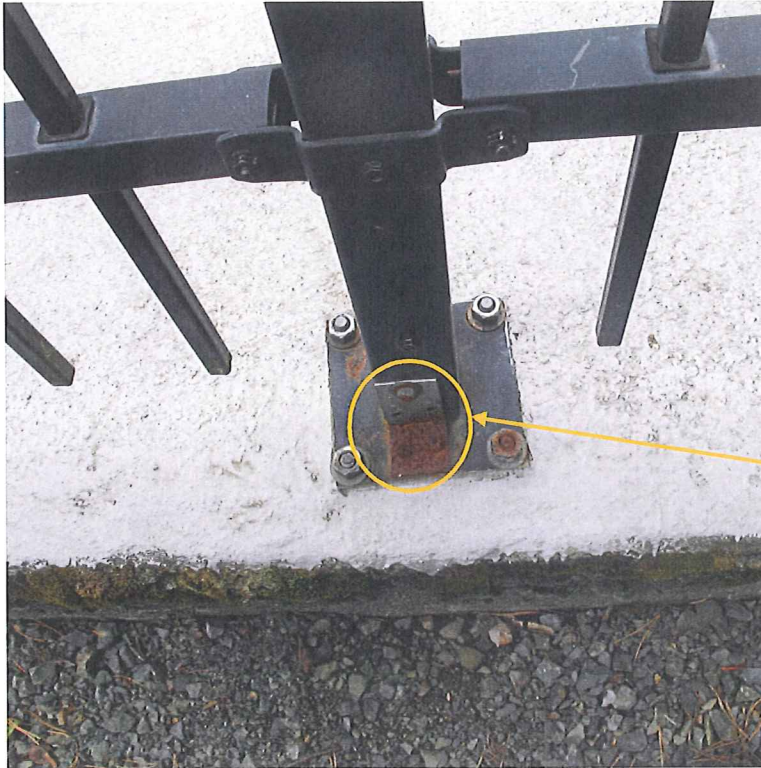
Photograph 3494

Photo 3494 shows broken fence bases that have been attempted to be repaired with light angles; with very little force the fence deflects.

Inadequate
angle

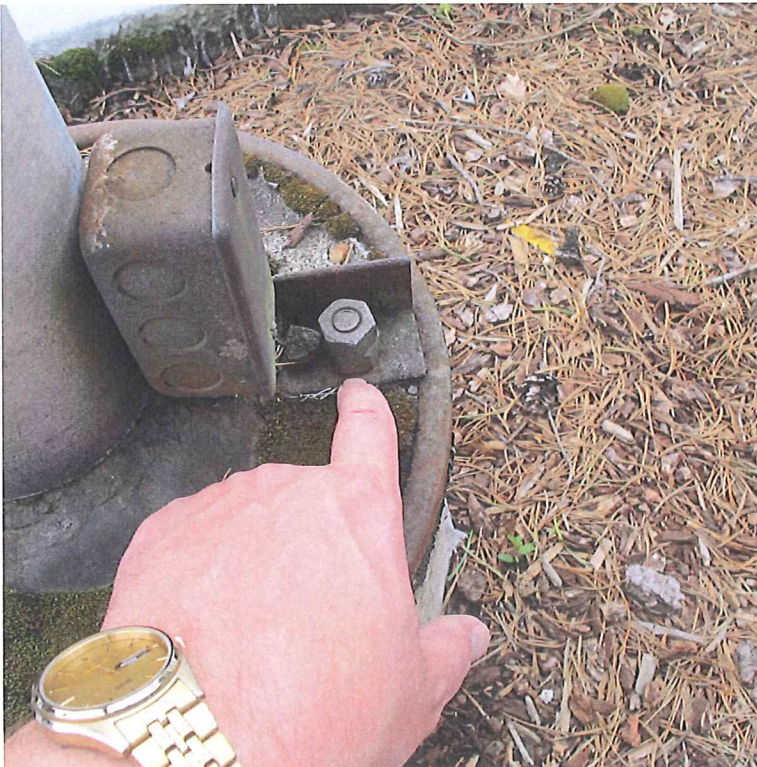
Photograph 3496

Photo 3496 shows a gap at the base of the fence post.

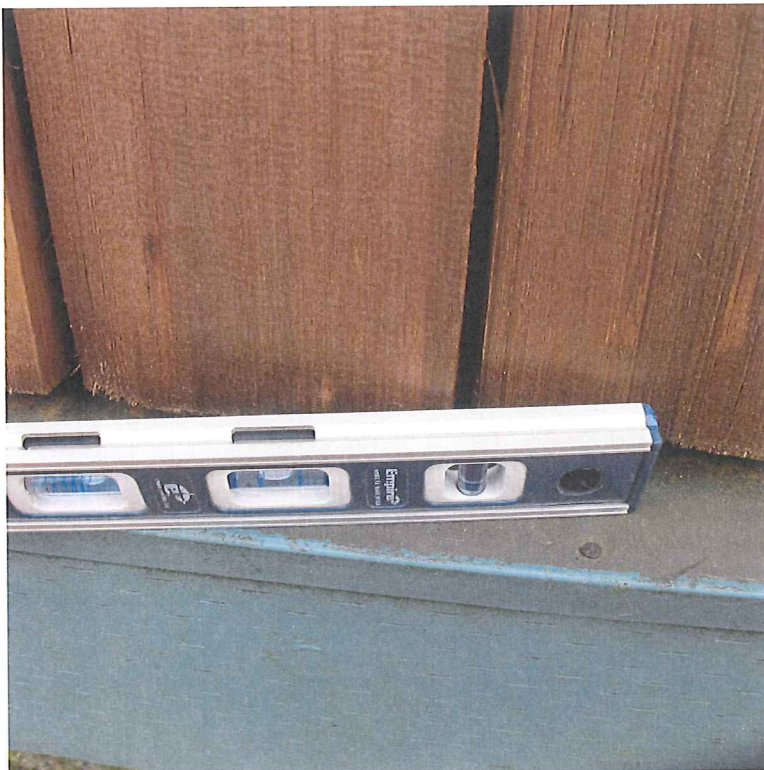
Photograph 3499

Photos 3497 and 3498 show deterioration of the exterior wood. Photo 3499 shows staining where the flashing has a reverse slope causing water to pond under the siding and leak through the nail holes in the flashing.
