MILLER
CONSULTING
ENGINEERS

Subject: Condition Assessment Report
2400 NW 153rd Avenue, Beaverton, Oregon
MCE Project Number: 140271

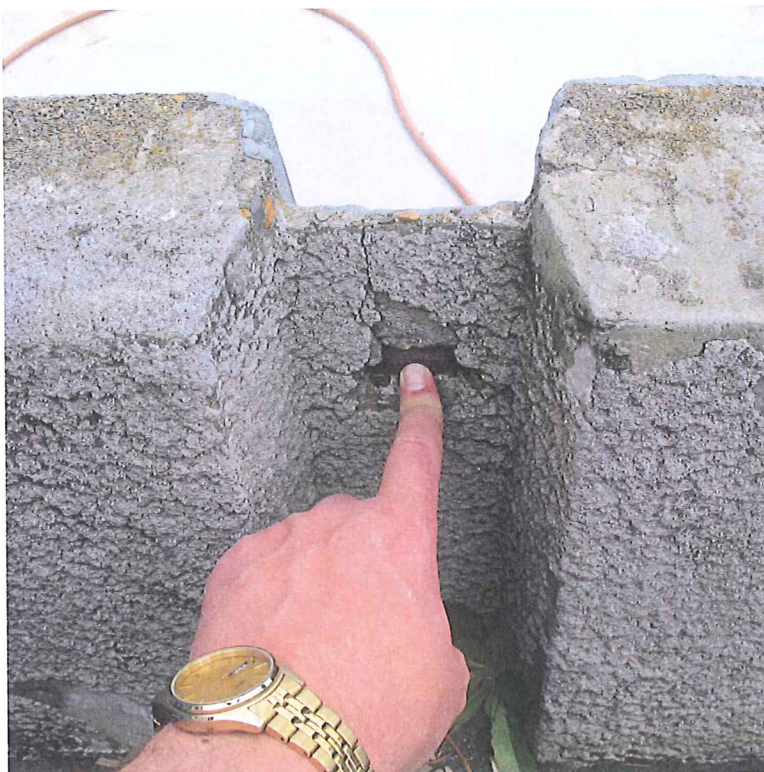
Photograph 3500

Photo 3500 shows more exposed steel in the concrete wall near the pool. The exterior of the wall appears to have the original finish. The side of the wall facing the pool has been painted.

The existing concrete walls have steel reinforcing. The concrete is spalling due to rusting of the reinforcing steel. We recommend that spalling concrete be removed to the point where the rebar only has minimal (light) corrosion. The rebar should be cleaned to bright metal and coated with a rich zinc primer and patched back with a repair mortar as prescribed by the manufacturer. Due to the shallow cover of the steel we recommend that the walls be sealed with a coating so as not to allow water into the concrete. The top of the walls should be sloped so as not to let water pond.

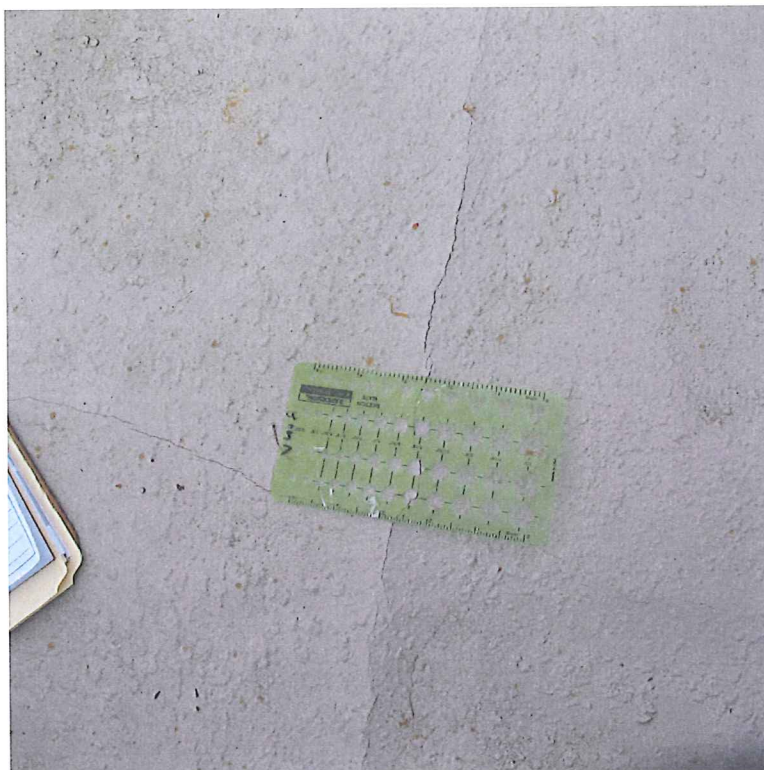
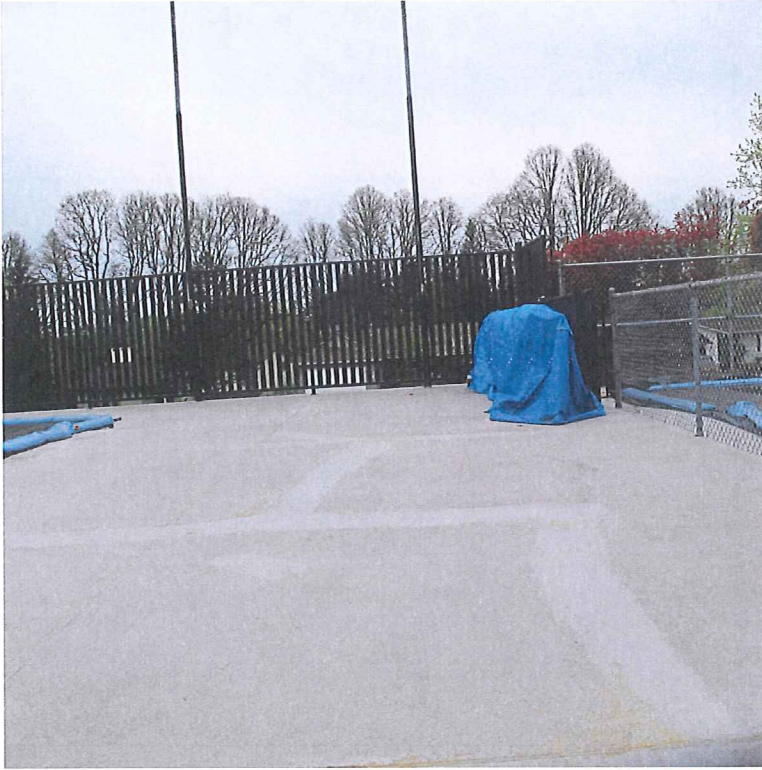
The existing pool deck was reported to have been coated in the last couple of years. The existing coating appears to have covered the cracks in the concrete that were acting as expansion and contraction joints. This has caused the coating to buckle.

Photos 3505 – 3511 and 3522 - 3526 show the pool deck patches that have buckled and in addition show patching that covers the expansion joints in the pool.

The pool deck coating is cracked and buckled. This appears to be a result of applying coatings over cracks in the concrete deck that continue to move. At these locations, the coating should be removed and the cracks be ground out and the joint should be filled with sealant like the other joints in the concrete deck. The deck coating should be re-applied up to the edge of the joint.

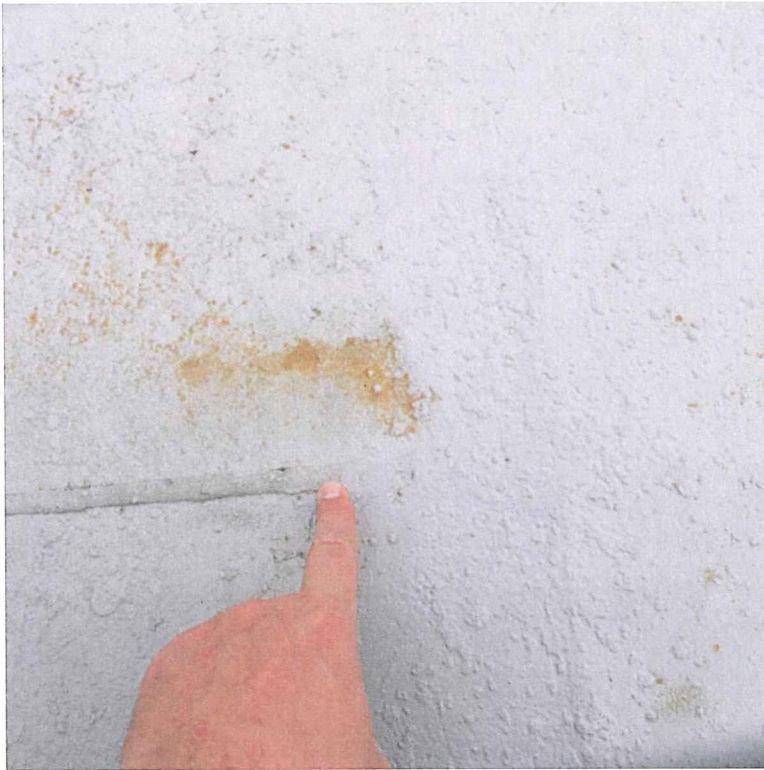
Photograph 3511

Photo 3511 shows un-caulked joints in the concrete slab on grade allowing water to undermine the slabs.

All joints in the concrete decks should have sealant to avoid water penetrating between the joints.

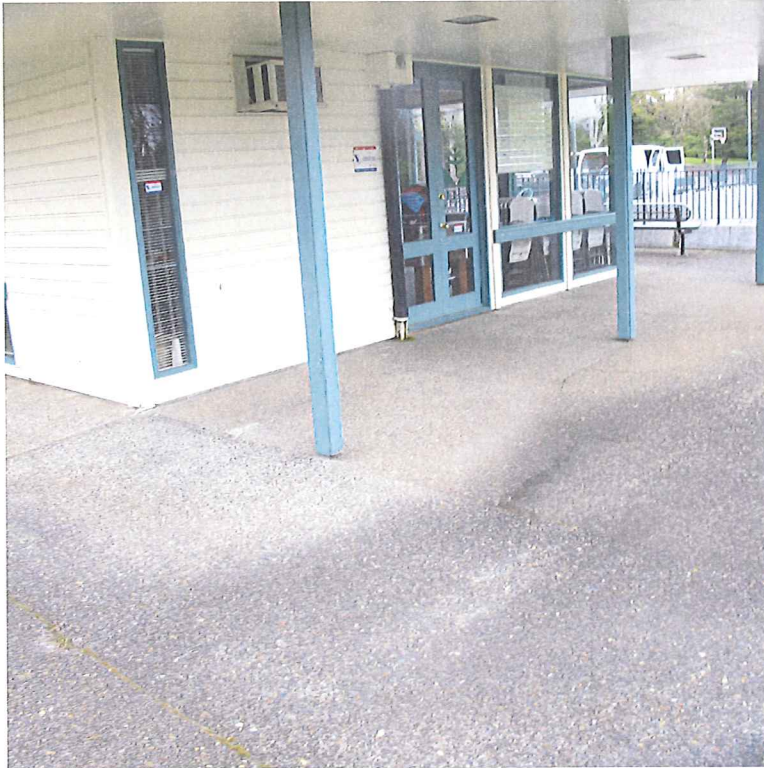
Photograph 3533

Photo 3533 shows the building roof drain is plugged and overflowing. This is near the location of the leaks in the shower room below.

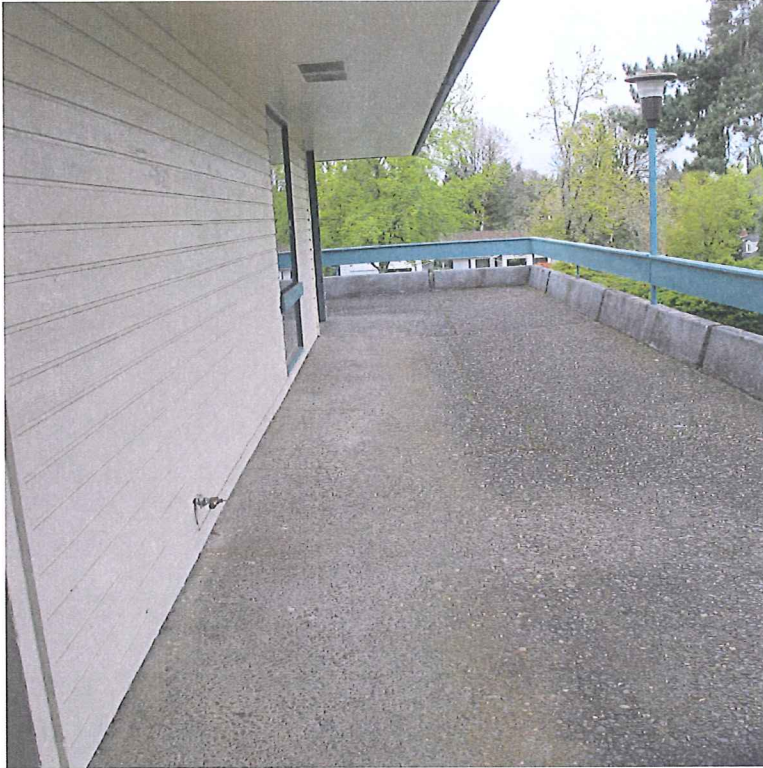
Photograph 3555

The slab on grade around the perimeter of the building is indicated on the drawings to slope away from the building to the drains near the concrete wall. Photo 3555 shows the dip in the center of the slab. Our survey indicates that the slab is over 3" lower than the adjacent drain at this location.

Based on Mark's report of the unsuccessful attempt of slab jacking the exterior slab in the past along with the continued settlement of the exterior slab, we recommend that the existing slab on grade be replaced along with any incompetent fill. This will also be an opportunity to replace the waterproofing of the elevated slabs.
