MILLER
CONSULTING
ENGINEERS

Subject: Condition Assessment Report
2400 NW 153rd Avenue, Beaverton, Oregon
MCE Project Number: 140271

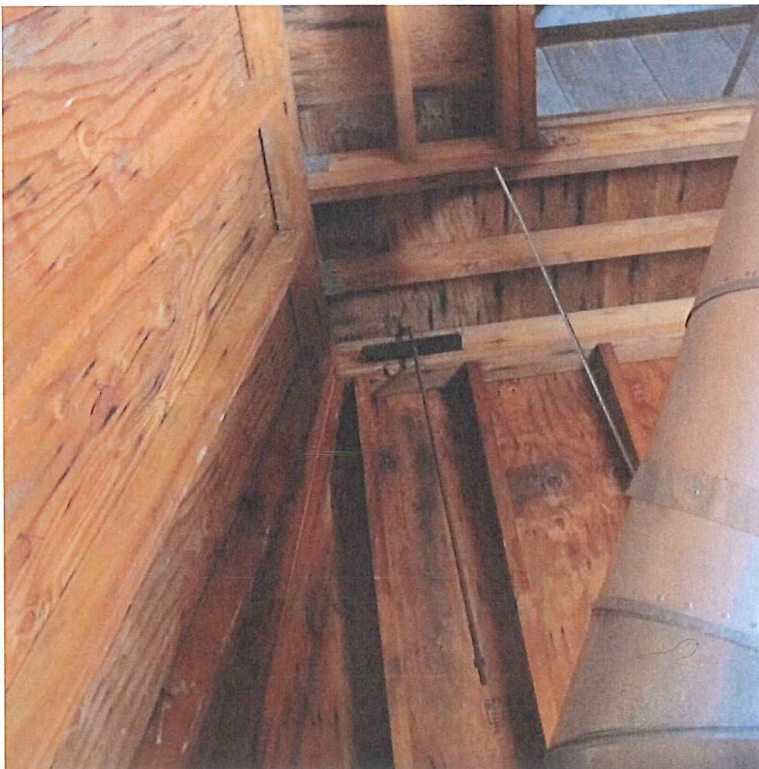
Photograph 3422

The roof and walls appear to have wood deterioration. Photo 3415 shows the staining of the roof and upper walls of the building. Photo 3424 shows deterioration of the studs near the door. Photos 3425 and 3430 show decay of the door and the surrounding door framing. The doors can no longer be secured due to the decay in the door and frames. The wood above the concrete walls are decayed in several locations. (See photos 3422 - 3435.) The lifeguard room door and floor are also decayed; see photos 3437 and 3440.

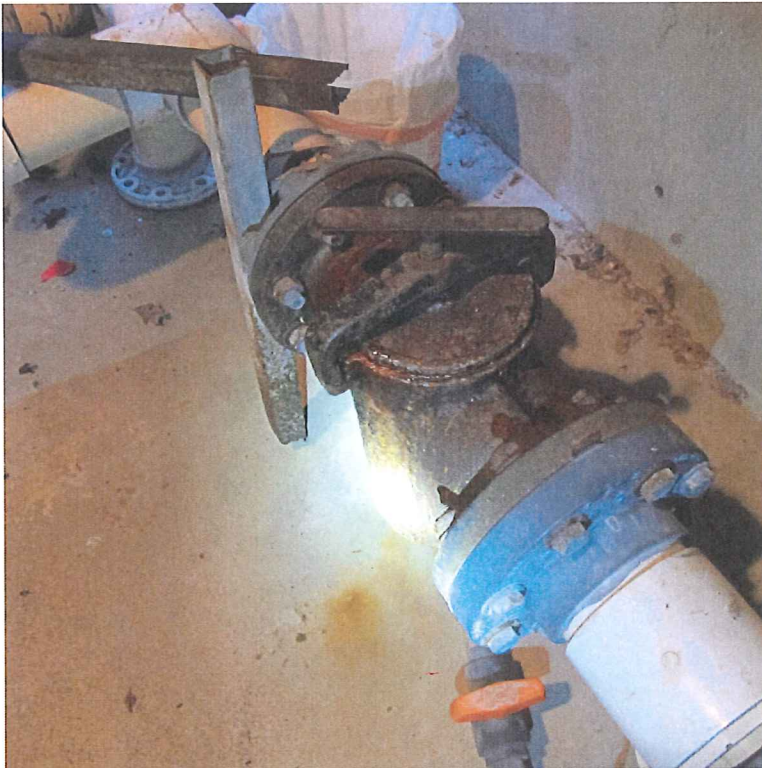
Photograph 3458

The mechanical piping is poorly supported and some of the supports have rusted away and do not bear on the concrete; see photos 3458 and 3459. Other supports do not have a positive connection to the concrete or the pump; see photo 3457.

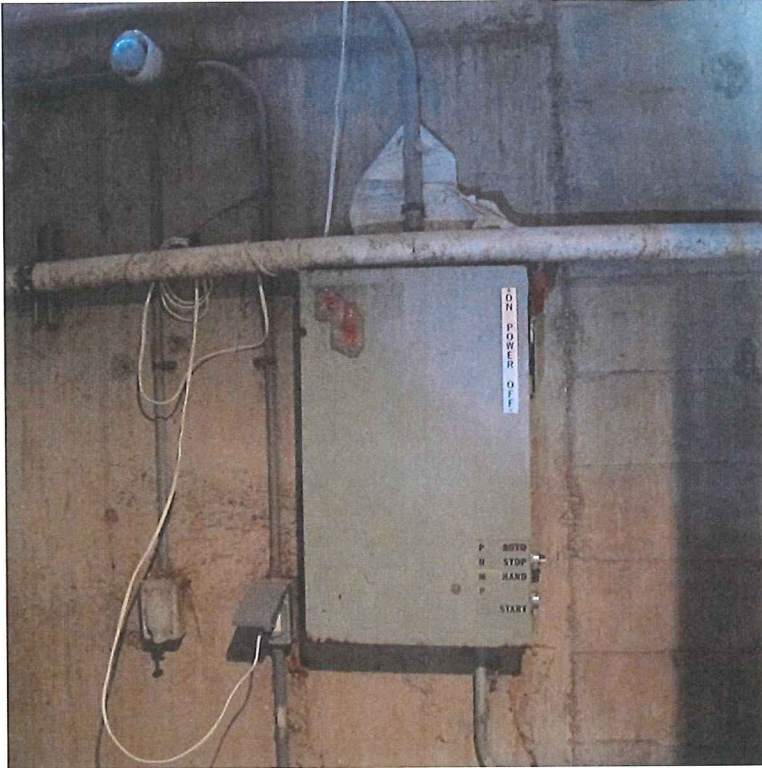
Photograph 3461

Photo 3456 shows a PVC pipe bracket that has come loose that is also supported by an electrical panel shown in photo 3461.

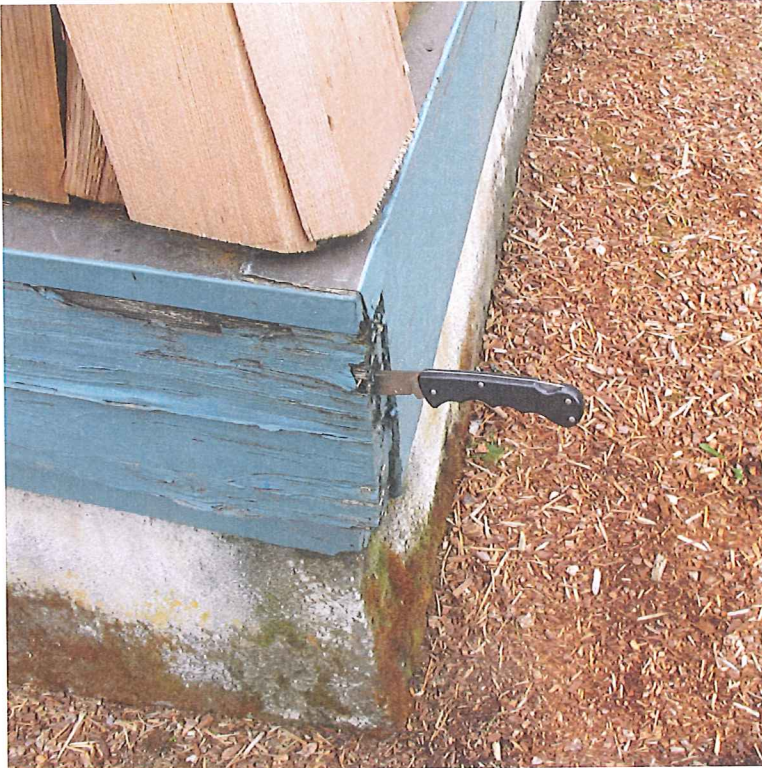
Photograph 3497

Photos 3497 and 3498 show deterioration of the exterior wood. Photo 3499 shows staining where the flashing has a reverse slope causing water to pond under the siding and leak through the nail holes in the flashing.
